Garrett Wade

Technical Memo T21

Re: 23N02.01 23N02.02 23N02.10

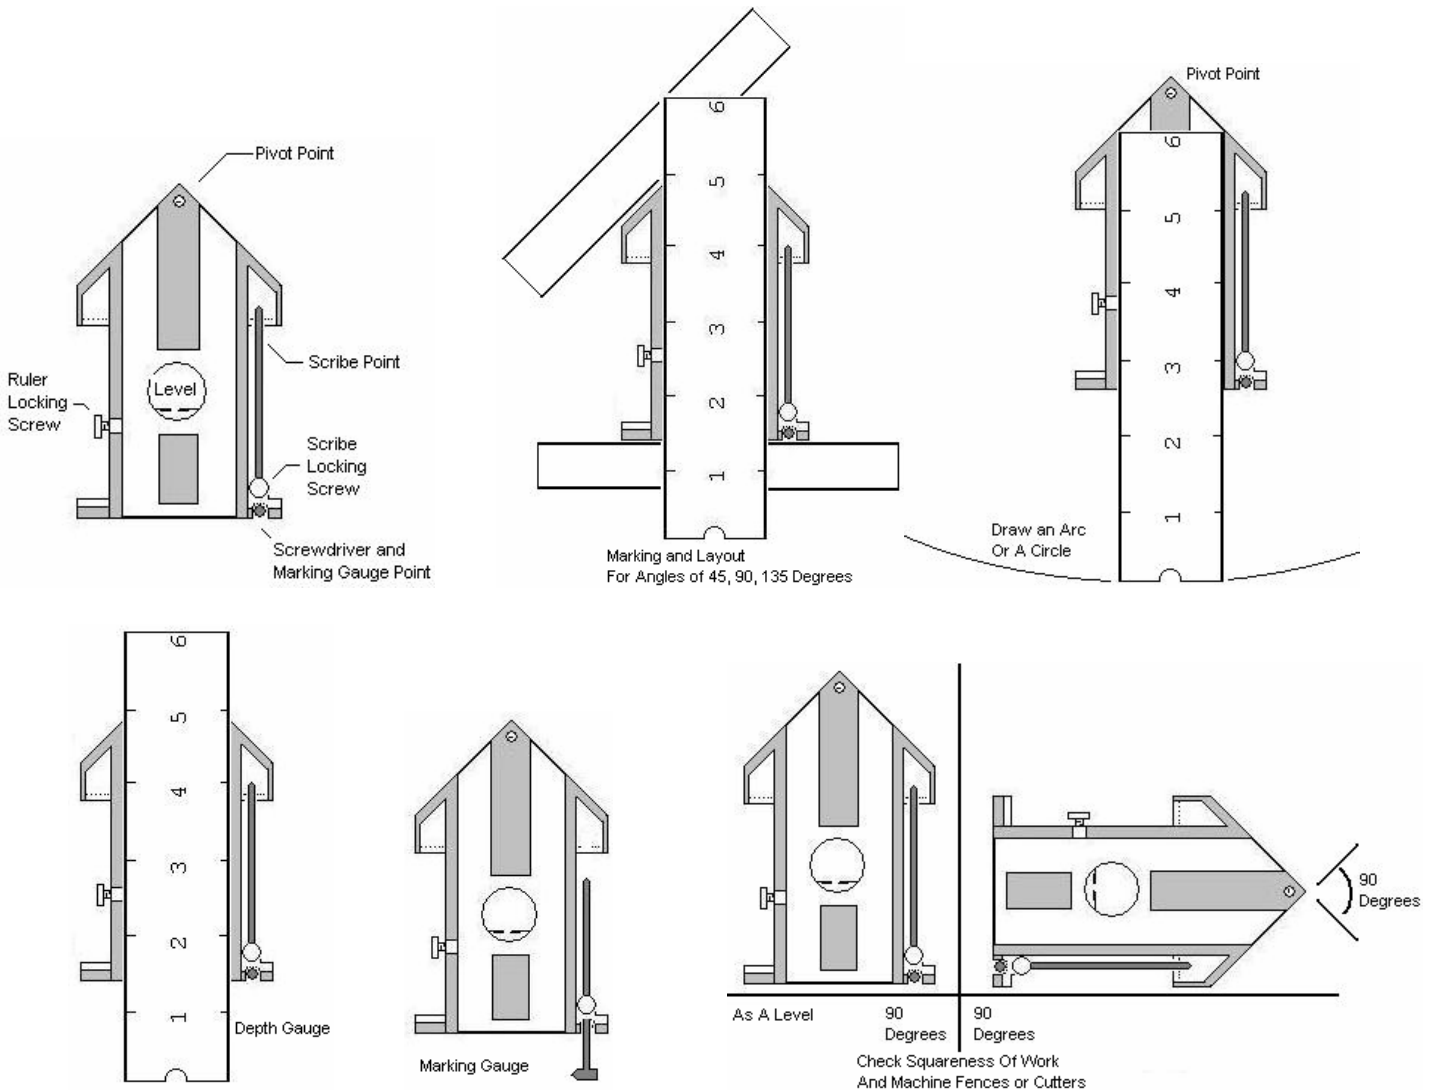
Special Note: Sometimes the screwdriver on the scribe does not fit the slot of the pivot screw. This can easily be corrected with a small file by removing any burrs left on the tip from the machining process. Simply filing the flats of the tip a few times will correct the problem.
